# Observed Damage Patterns and Material Strength Deficiencies in URM Dwellings After the 2019 Albania Earthquake

Marjo Hysenlliu

Department of Mechanics of Structures, Polytechnic University of Tirana, Albania  
mhysenlliu@gmail.com

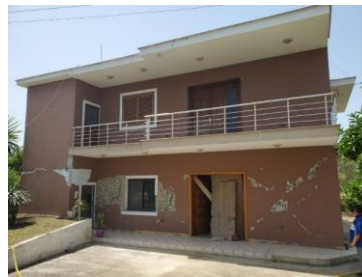
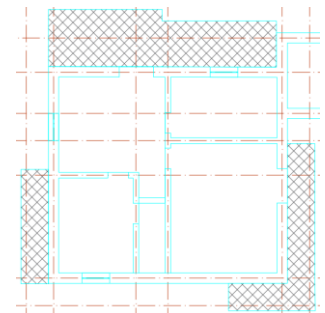
Fig. 1 Building façade photos (right), plan view (left).

- Building 1 - A two-storey URM dwelling with relatively regular plan geometry. Damage was concentrated in ground-floor walls,

where diagonal cracking and corner separation were widely observed.

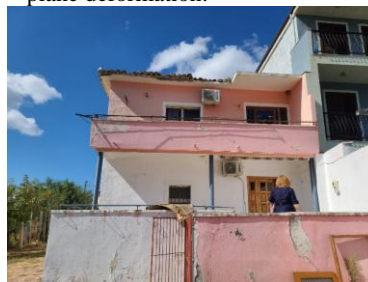
Fig. 2 Building façade photos (right), plan view (left).

- Building 2 - This house includes several large openings and slender wall segments. Shear cracking and wall-slab separation were prominent, and several panels showed signs of partial out-of-plane deformation.

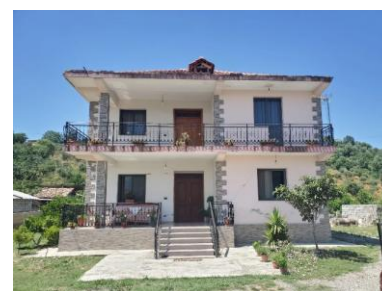
Fig. 3 Building façade photos (right), plan view (left).

- Building 3 - A URM structure with poor mortar quality confirmed during inspection. Extensive diagonal cracks and crushing around window openings indicated limited material cohesion and weak tensile resistance.

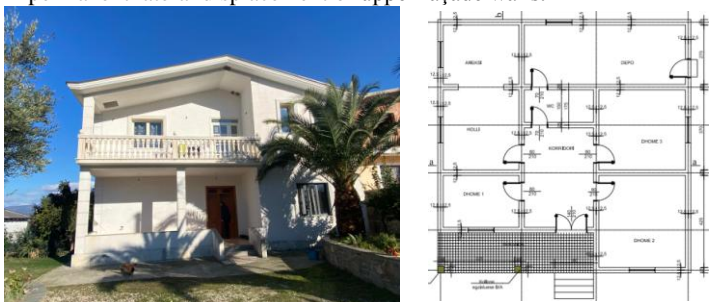
Fig. 4 Building façade photos (right), plan view (left).

- Building 4 - The most heavily damaged among the four, featuring widespread shear cracking, vertical splitting at corners, and permanent lateral displacement of upper façade walls.

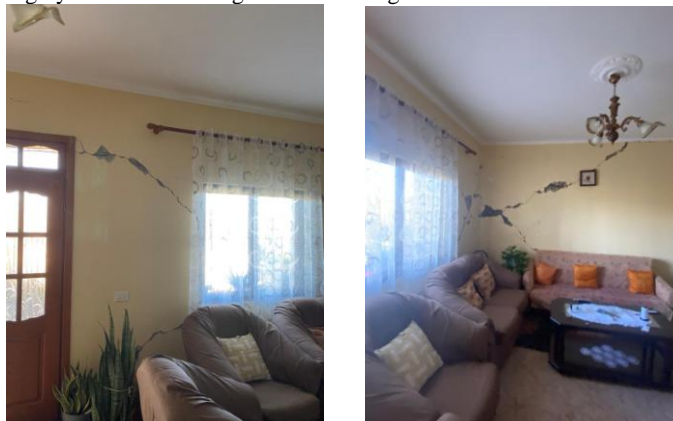
Fig. 5 Building 4 damage around openings.

Damage was also concentrated around door and window openings, where cracks radiated from lintel corners and localized crushing was observed above openings. These effects reflect the limited compressive strength of the masonry, which restricts its ability to redistribute stress concentrations around structural discontinuities.

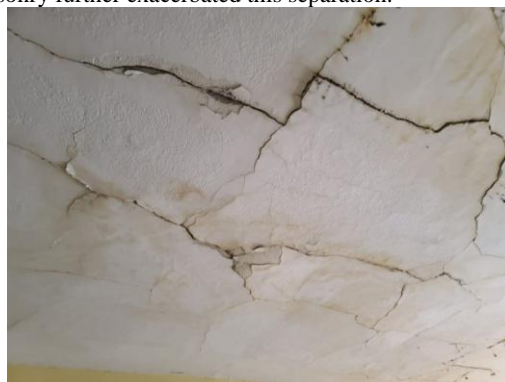
In all four dwellings, horizontal cracking and separation were observed at the wall-slab interface. Timber floors or weak concrete slabs provided limited diaphragm action, allowing relative movement between walls and slabs. The poor bonding capacity of the masonry further exacerbated this separation.

Fig. 6 Building 2 slab degradation and separation from walls.
