Acoustic emission method of diagnostic of elevating rudder covering in places of lightning strikes impact

KEYWORDS: acoustic emission; diagnostics, elevating rudder; composite laminate; lightning stroke.

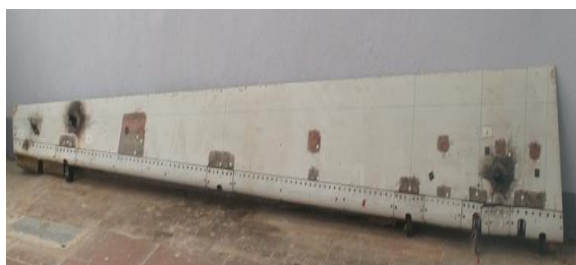
Fig.1. The elevating ruder after lightning strikes impact by the end of crushing tests.

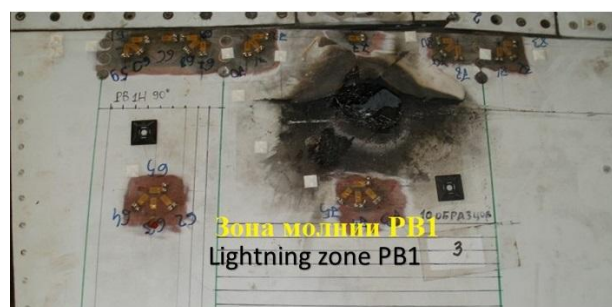
The zones of lightning impact on the elevating rudder in the area of the root and end parts are shown in Fig. 2, from which it can be seen that there is one in the root part, and two places of lightning impact in the end part.

a) The root part of elevating rudder.

Fig.2. The zones of lightning impact on the elevating rudder.

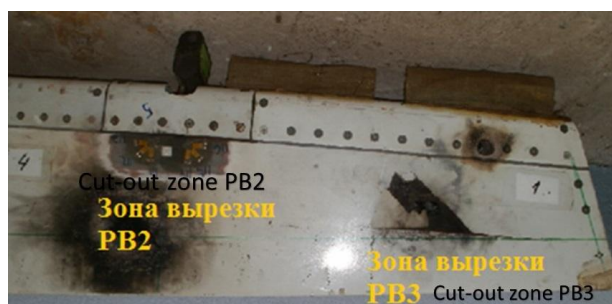
b) The end part of elevating rudder.

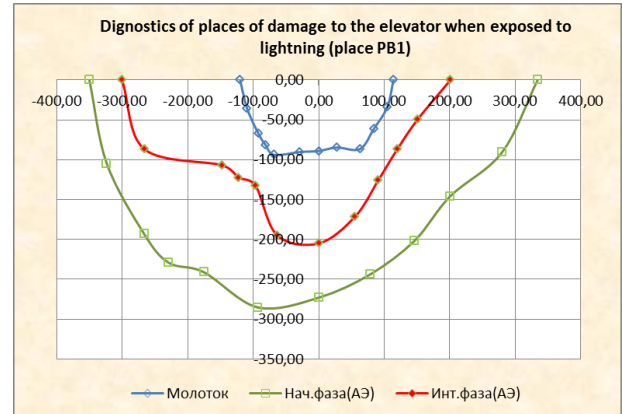
Fig.6. Dignostics of PB1 zones in the root part of the elevating rudder. Blue - hammering, red - intensive crushing (acoustic emission method) and green - initial damage (acoustic emission method).

- ✓ the zones of change in the structure of the composite material near the places of lightning impact were determined;
- ✓ the zone of a strong change in the structure of the material was found by manually tapping the covering directly near the destruction zone and is an ellipse for the PB1 zone with dimensions of 100x200 mm

- ✓ the zone of intense and initial changes in the structure of the composite was determined by the acoustic emission method (intense - 350x500 mm);
- ✓ it is necessary to conduct strength tests of the samples of the elevating rudder covering in the zones PB1, PB2 and PB3 and compare the obtained characteristics with the characteristics of samples from undamaged covering to confirm the diagnostic results. [3;4]

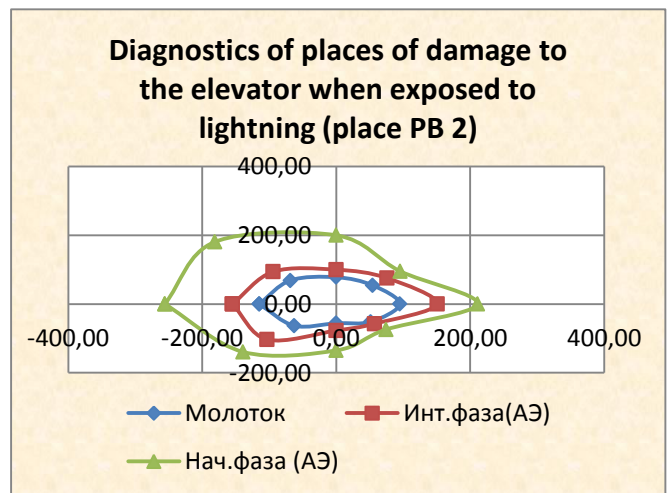
Fig.7. Dignostics of PB2 zones in the root part of the elevating rudder. Blue - hammering, red - intensive crushing (acoustic emission method) and green - initial damage (acoustic emission method).

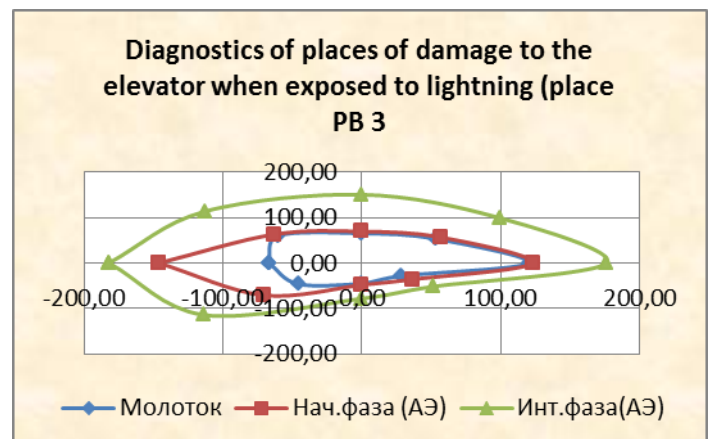
Fig.8. Dignostics of PB3 zones in the root part of the elevating rudder. Blue - hammering, red - intensive crushing (acoustic emission method) and green - initial damage (acoustic emission method).

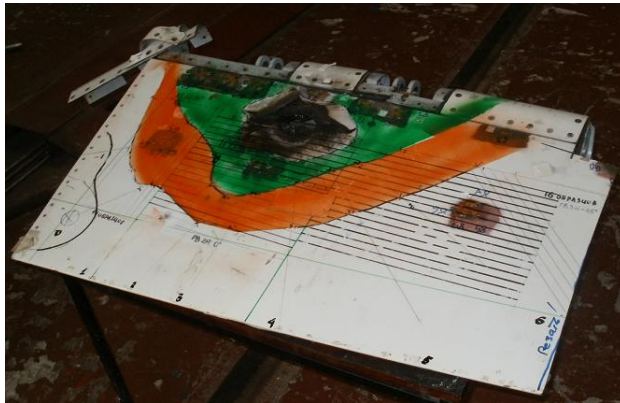
On Fig.9. Zones of diagnostics of the elevating rudder PB1 are applied the object of diagnostics (the root part of the elevating rudder): central unpainted - material delamination by taping; middle orange - intensive phase of AE and extreme blue - initial phase of AE.

Fig.9. Zones of diagnostic of the elevating rudder.
