# THE RESULTS OF BLAST LOADING OF REINFORCED CONCRETE SPECIMENS WITH VARYING FIBRE TYPES AND CONTENT

M.Sc. Petkov Y<sup>1</sup>, Assoc. Prof. M.Sc. Ganev R. PhD. <sup>1</sup>, Prof. M.Sc. Lilov I. PhD<sup>2</sup>  
 Higher School of Civil Engineering (VSU) "L. Karavelov" – Sofia, Bulgaria<sup>1</sup>  
 National Military University, Veliko Turnovo, Bulgaria<sup>2</sup>

**Abstract:** The experiment report presents the results of the field tests of fiber-reinforced concrete (FRC) and reinforced concrete specimens which were performed by research team from Faculty of Civil Engineering, Czech Technical University in Prague, Czech Republic in cooperation with the Czech Army corps in the military training area Boletice. The tests were performed using real scale reinforced concrete precast slabs (6×1.5×0.3m) with varying fibre content, fibre type, fibre strength and concrete strength class and 25 kg of TNT charges placed at a distance from the slab for better simulation of real in-situ conditions. The slabs were recorded using a high speed framing camera during the blast loading. The instrumentation enabled us to study the propagation of the blast shock wave through the material, propag

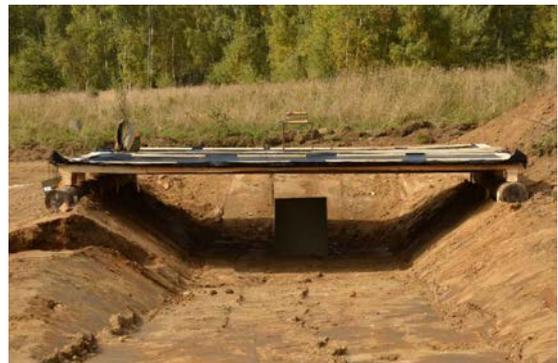
Fig. 1 Layout of the experiment.

The layout of the experiment is shown on fig. 1.

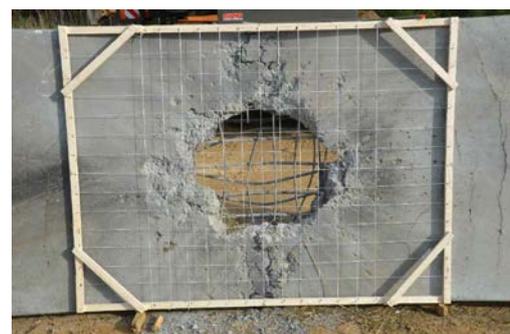
The timber frame with string grid of 100mm was used to measure area and depth of concrete spalling and puncture. The method of data evaluation can be seen in Fig. 2.

Fig. 2 Timber frame with string grid to experiment data evaluation.
