THE IMPACT OF TRIBOCORROSION ON WEAR OF WORK PARTS OF THE SCREW PRESS

Abstract: In the production of oil in the oil mill parts of the equipment wear due to contact with seeds which contain microabrasive particles. This wear manifests itself by changing the dimensions and geometry of the screw press. The paper analyzes the influence of tribo-corrosive wear on the workpieces of the screw press. The appearance of wear is most likely due to the action of aggressive media, in this case the oilseeds. In the experimental part of this paper, on samples made of cast steel and austenitic stainless steel, following laboratory tests were performed: electrochemical testing, testing of chemical composition of the base material, wear analysis, microstructure recording and hardness testing. Based on the laboratory testing, conclusion was that the austenitic stainless steels 304L and 316L with nitrated surfaces exhibit better resistance to tribo-corrosion wear in relation to cast steel GS-42CrMo4.

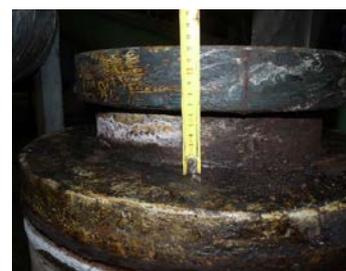
Figure 1 Appearance of damaged gearbox.

After a visual inspection, conclusion was that damage of the working parts of the screw press came for several reasons. One of them was damage of the gear unit housing, which resulted in the unauthorized eccentric "swinging" of the colander and the appearance of tribo-corrosion on its parts, Figure 1.

Reason for the high wear of the base material caused by the corrosion is aggressive media which passes between half-rings and reducers housing. To solve this problem, silicon sealing compounds are mounted between the half-rings and the reducers housing. However, because of the high temperatures, these gaskets hardened during operation, allowing aggressive media to pass.

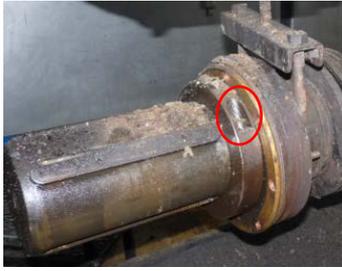
Figure 2 Appearance of damaged reducers half-ring.

Figure 2 shows the detail of the damaged half-ring on the contact surface of the gear unit housing. Half-rings are made of austenitic stainless steel AISI 304L and 316L, after which they are placed on the contact surface. Half-ring tightening is done by the appropriate screws made from the same stainless steel. By control with the portable spectrometric chemical analyzer it was determined that the gear housing was made of cast steel Cr-Mo, and with portable hardness measure device it was found that the hardness of its surface ranged from 210 to 235 HB. With detailed surface control, conclusion was that damage is most likely caused by the action of aggressive media (sour soups), and manifested it by the appearance of tribo-corrosion on the parts of the reducer which are in contact with the settling surfaces of the colander.

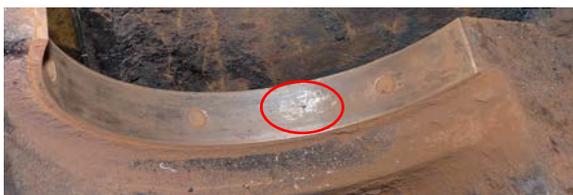
Figure 4 Appearance of the damaged colanders half-ring.

Damages of the colander is the second reason for the end of the functional operation of the screw press. On the part of the colander located in the gasket with the gear housing, traces indicate damages due to eccentric motion in the contact area of the enclosure casing/colander, but also traces that can be attributed to tribocorrosion. After disassembling the half-ring, there are also some damages visible on the base material of the screw press. These damages are most likely the effect of action of the aggressive media (sour soups), Figure 4.

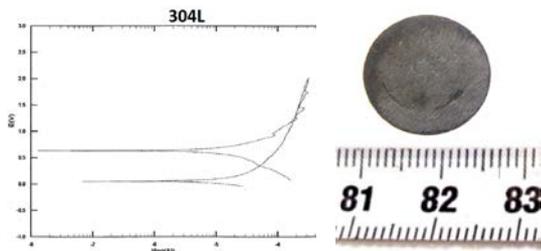
Figure 5 Cyclic polarization diagram and macro recording of sample 304L.

After conducting polarization measurements, macrostructure recording was performed. Figures 5, 6 and 7 show cyclic polarization schemes and images of recorded macrostructure patterns.

Results of electrochemical testing (shown in Table 2) show that materials AISI 304L and AISI 316L have significantly higher values of polarization resistance R_p in relation to the material GS-42CrMo4, which has a twenty times lower polarization resistance value. The corrosion rate values for austenitic stainless steel are fairly similar, but for cast steel GS-42CrMo4 are 14 times bigger in relation to the austenitic stainless steels. Cyclic polarization diagram (Figures 5 and 6) show that nitrated samples of austenitic stainless steel 304L and 316L are not tended to pitting corrosion, while the material GS-42CrMo4 (Figure 7) shows tendency to the pitting corrosion. This confirms the image of the macrostructure of the surface after the test (Figure 7) with highlighted pitting. Metallographic analysis of test samples show that samples made of material 304L and 316L (Figures 8 and 9) have austenitic structure with recognizable double crystals that have finely divided the various precipitates. In addition to the sample boundary, there is a specific nitric layer followed by the austenitic structure of the base material. Cores of both samples also have austenitic microstructure. Microstructure values on the cross section of samples 304L and 316L are measured from the edge to the core (Tables 3 and 4) show that the microhardness of the samples is the same and adequate for the applied method of surface modification by nitrating.

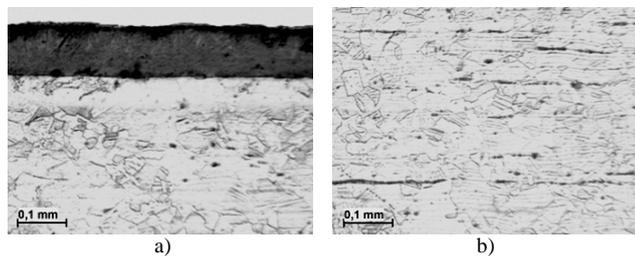
Figure 8 Characteristic microstructure of test sample 304L. a) edge; b) core

Metallographic and hardness test give the complete information about the material before and after the nitration process. The microstructure of test samples was analyzed at their edges and in the core. Samples made of stainless steel were wiped in glycerin, while the sample made of cast steel was wiped in nital (2 %). The characteristic microstructure of the edge of the sample 304L is shown in the Figure 8.a., while the characteristic microstructure of the core is shown in the Figure 8.b.

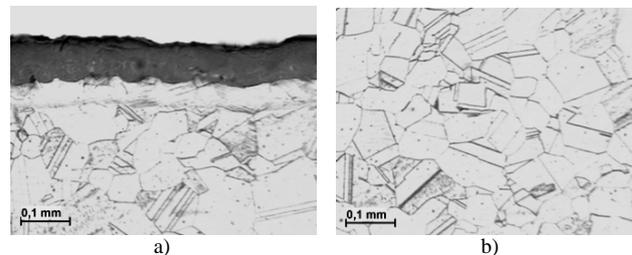
Figure 9 Characteristic microstructure of test sample 316L. a) edge; b) core

Characteristic microstructure of the edge of test sample 316L is shown in the Figure 9.a., while the characteristic microstructure of the core is shown in the Figure 9.b.

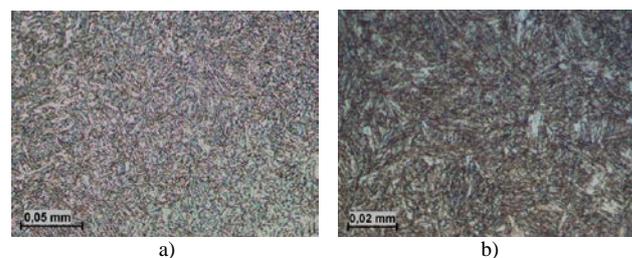
Figure 10 Characteristic microstructure of test sample GS-42CrMo4.

Characteristic microstructure of test sample GS-42CrMo4 is shown in the Figure 10.
