# Innovative design for repair of corrected industrial reinforced concrete structures of light soda silos - Solvay Sodi AD, Devnya

**Abstract:** The report discusses the main parameters of a developed design and technological project for the implementation of specific repair and restoration works of built in the mid-1970's corroded concrete reinforced structures of LIGHT-SODA SILOS – SOLVAY SODI JSC. The purpose of the design is to comply with the requirements for reasonable sufficiency of the additional new steel-reinforced concrete coating (jacked) to realize a lightweight variant of the protective layer against corrosive production factors, atmospheric influences and other specific chemical impacts. The project envisages a technological variant for the implementation of an additional healing thin repair reinforced concrete layer (overlay), based on the specific characteristics of high-tech hybrid fiber-reinforced "wet" sprayed concrete with the participation of specially selected high-range water-reducing and internal-crystallization chemical admixtures. The report provides information on the basic physical-mechanical and technological characteristics of the "wet"-sprayed concr

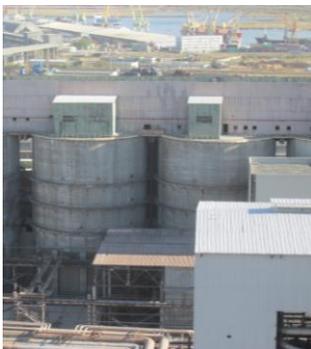
The steel reinforced concrete structures of LIGHT SODA SILOS "4" & "5" - SOLVAY SODI AD, DEVNYA, were built in 1973 and they still operate under the combined impact of exploitation and environmental factors, some of which display significant corrosive potential. The latter violated the quality of the steel reinforced concrete, and serious corrosive damages were located within specific areas - **Photos 1 and 2**.

Photo 1 LIGHT SODA SILOS "4" & "5" general view

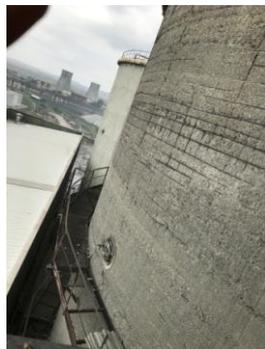
Photo 2 LIGHT SODA SILOS "4" & "5" typical concrete damages

Visit and visual inspection of the reinforced concrete structure has been performed to confirm or clarify the records data. The existing reinforcement steel was specified (A-III) as well as the concrete class (grade 300 ~, concrete compressive cube strength is 22,5 MPa). It should be noted that no essential damages have been observed in the reinforcement of the elements. Significant part of it is visible in the areas exposed to weather (the side of the columns, which is in contact with the outside air, the external cylindrical part of the silo body) but the visible reinforcement steel is in relatively good condition. The silo funnel (conical hopper), the supporting ring beam and the internal columns are predominantly in relatively good status and there is almost no visible reinforcement. Damage on the covering of the internal elements is observed only in the areas of leaks between the steel roof structure at level 15,00 and the silo.

Shotcreting of a new special concrete layer ("jacket"), without the use of formworks, employed to recover the initial cross section, seems to be the most appropriate technological method. Such an approach is adopted as a basic one in the present technical project, where as a technical-economical comparison between the two methods of shotcreting - "dry" and "wet" concrete covering, shows imperative advantages of the "wet" one [1,2]. The design envisages a technological variant for the implementation of high-tech hybrid fiber-reinforced "wet" sprayed concrete with the participation of specially selected high-range water-reducing and internal-crystallization chemical admixtures.
