Study of the effects on engine fuel consumption generated by turbocharger performance

Abstract: Damage to the turbocharger of the 8400kW diesel engine, which had operated about 66 640 running hours, has caused off hire of the vessel for 10 days and the turbocharger repair had cost more than half a million euros. The study performed on this work consists of evaluating the consequences of the low turbocharger performance on the fuel oil consumption and the reasons for this. Specific data were collected and analysed in order to create an appropriate mathematical model between the studied parameters. Measurements and data collected were performed a month before turbocharger damage and after the TC overhaul (with new cartridge). As results can be concluded that losses in turbocharger performance is very important for the efficient operation of the main engine, they must be monitored and analysed.

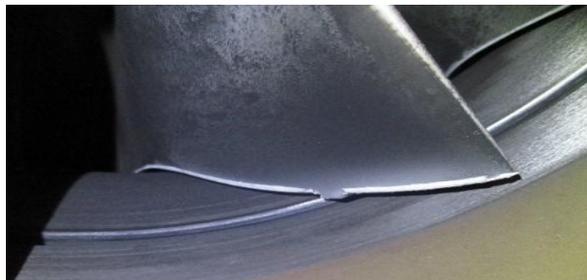
Considering the information available following possible failure causes could have led to the failure of cartridge smooth rotation and the excessive axial movement of compressor wheel supports increase of clearances in radial and axial bearing beyond the limits. This further validates that the bearings and shaft have worn beyond usable limits. The rubbing of the compressor wheel (fig.3) with wall insert may be the consequential damage [3, 10, 11].

Fig. 3: Rubbing of the compressor wheel.

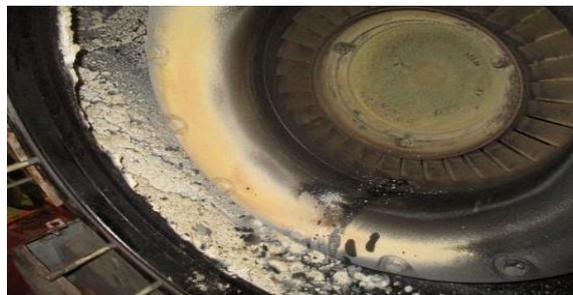
Fig. 4: Presence of unburnt oil along with carbon deposits.

Inspection of other components on board (refer figure 4) relates the fact that there was presence of unburnt oil along with carbon deposits. This could likely be the reason of unbalance in the shaft which might have led to rubbing of compressor wheel and ultimately leading to failure of other components.

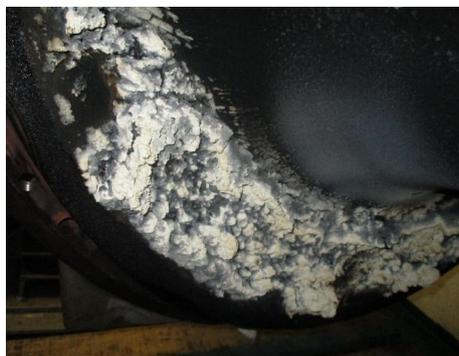
With regard to contamination (fig. 5), water has penetrated in the gas outlet housing, which has caused contamination by mixing with unburnt oil and carbon [1], leading to unbalance in the shaft and further causing failure of other components.

Fig. 5: Contamination by mixing with unburnt oil, carbon, water.
