Acoustic emission method of diagnostic of elevating rudder covering in places of lightning strikes impact

KEYWORDS: acoustic emission; diagnostics, elevating rudder; composite laminate; lightning stroke.

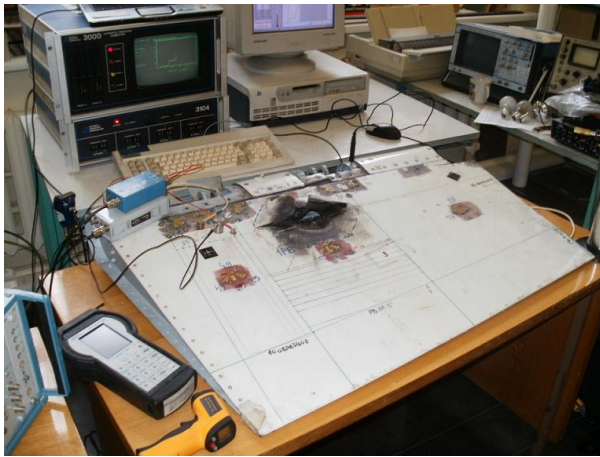
Fig.3. The diagnostic of the elevating rudder's part by AE method.

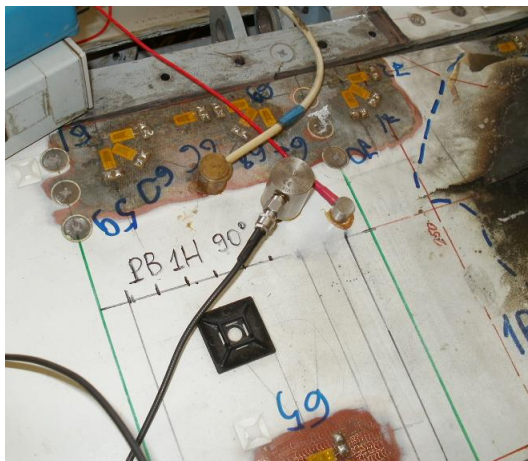
Piezo sensors attachment on the construction of the skin of the elevating rudder is shown in Fig.4. Triple reservation of AE measurements was carried out (three independent sensors and measuring devices) to strengthen reliability of diagnostics.

Fig.4. Piezo sensors attachment on the construction of the skin of the elevating rudder.

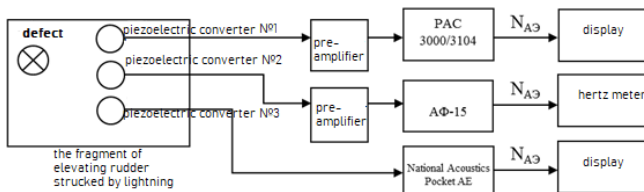
The block diagram of acoustic emission measurements for the elevating rudder's notch zones, from where the triple reservation of the acoustic signal measurement can be seen, is shown in Fig.5.

1,5 см Block diagram of acoustic emission measurements for elevating rudder's notch zones.
