INVESTIGATION OF THE TRIBOLOGICAL CHARACTERISTICS OF THE STAINLESS STEEL X20Cr13

Abstract: For the purposes of testing tribological characteristics of the stainless steel X20Cr13 designed for the parts of process industry plants for the production of sunflower oil, test samples were made and heat treatment by improving on different hardnesses was performed. Final machine processing of the samples was performed out by grinding and polishing. This way, the different characteristics of the surface layer and the different surface topography were achieved. The paper presents the results of the impact of the hardness on characteristics of the stainless steel X20Cr13. By examining the resistance to the adhesion wear it was concluded that the higher wear was on the test samples which have been in the raw condition and who were also loaded by higher forces. Therefore, the quality of the surface wear greatly affects the surface roughness and the coefficient of friction.

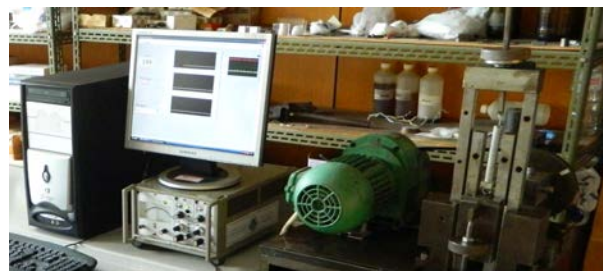
Fig. 2 Tribometer TR-95 [4].

Tribometer TR-95 allows varying conditions of contact in terms of shape, dimensions and materials of contact elements, the normal contact load and speed skating. Tests can be performed in conditions with lubrication and without lubrication. The basic configuration of the tribometer consists of: a drive system, system load, the system for managing, lubrication system, the system of self-adjusting blocks and measuring system, Figure 2.

The drive system consists of an electrical motor with pulleys, belts and variator that allows varying of the speed from 100 to 1200 r/min. There is a rotational disc on the main shaft. The system of loads by weight or steam allows load from 0 to 500 N.

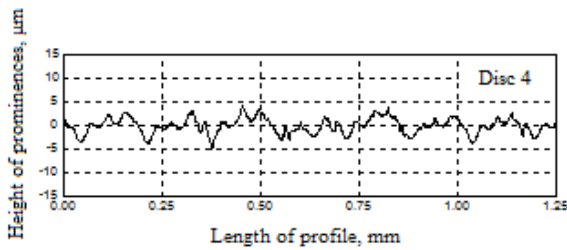
After the test for resistance to the adhesion wear was performed, the surface topography of test samples was conducted. Heat and final machining obtained different characteristics of the surface layer and the different surface topography of the test samples. Figures 9 and 10 are showing the different topography surface of the disc 4 in the new condition and disc 7 in the condition of the wear. Worn part of the disc and the topography of used parts can be seen.

Fig. 9 Representation of topography of the disc 4 in the new condition.

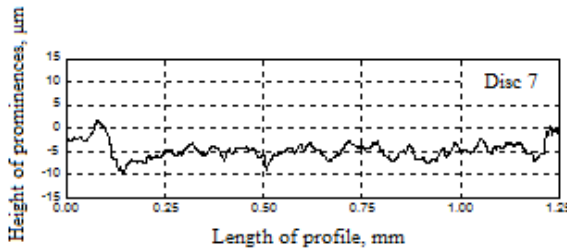
Fig. 10 Representation of topography of the disc 7 in the worn condition.

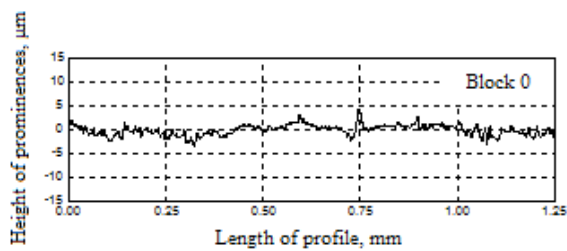
Figures 11 and 12 are presenting different surface topography in a new block 0 and block 6 in the wasted condition. In place of wear of the blocks width, depth and area of the worn part can be measured.

Fig. 11 Representation of topography of the block 0 in the new condition.

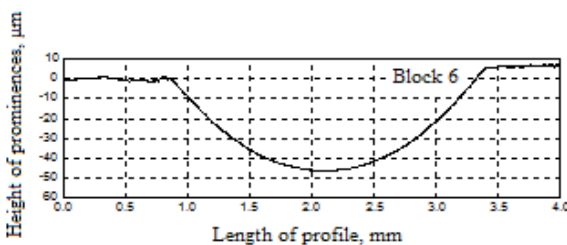
Fig. 12 Representation of topography of the block 6 in the worn condition.
